5 ISSUES AND IMPROVEMENT RECOMMENDATIONS

5.2 WISCONSIN AVENUE CORRIDOR

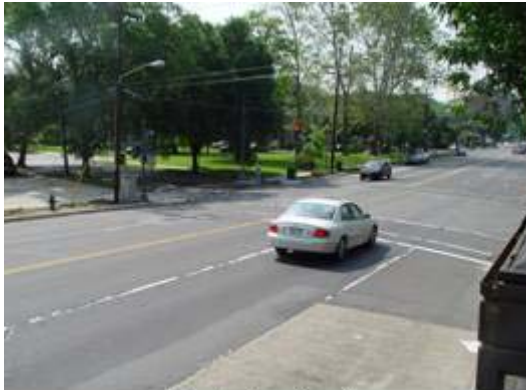
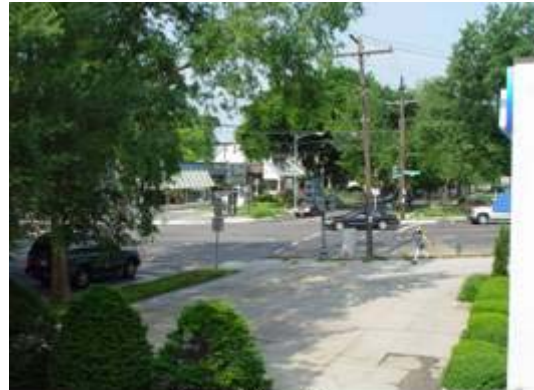
5.4.1 Wisconsin Avenue/Fessenden Street Intersection

- Poorly delineated pedestrian crossings.
- Faded lane striping.
- Significant traffic volume on eastbound and westbound Fessenden Street making left and right-turn movement onto Wisconsin Avenue. Currently, one shared left/through/right lane is provided in each direction.

- Re-stripe pedestrian crossing as recommended in Section 5.8 Pedestrian Safety.
- Re-stripe all approaches of the intersection. Include separate left turn lane and through/right lanes on the westbound approach.

- Replacing the striping at this intersection will improve visibility and safety.
- Adding a designated left-turn lane on Fessenden Street will increase intersection capacity and safety.
- Operation as a semi-actuated system will reduce stops and delays on Wisconsin Avenue.

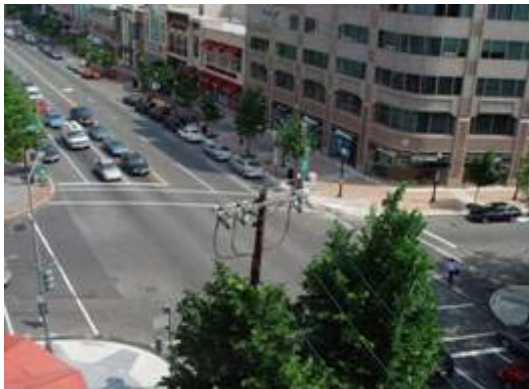
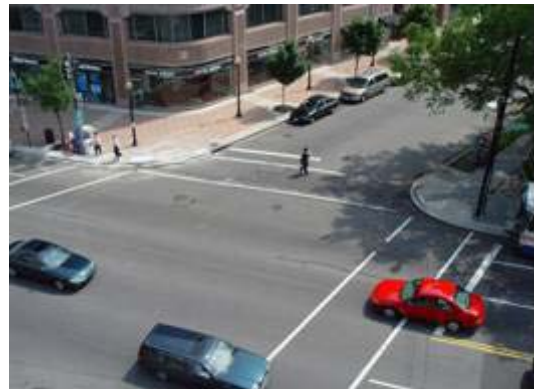
5.4.2 Wisconsin Avenue/Jenifer Street Intersection

- Lack of lane striping.
- No defined separate right-turn lane on Jenifer Street heading eastbound.
- Inadequate crosswalks and sidewalks for north-south crossings at northeast and southwest corners of this intersection.

- Replacing the striping at this intersection will improve visibility and safety.
- Removing parking meters will improve capacity of Wisconsin Avenue between Jenifer Street and Western Avenue. Enhanced flow on Wisconsin Avenue may reduce traffic turning onto Jenifer Street and 43rd Street to get to Military Road eastbound.
- Proper positioning of sidewalks/crosswalks is essential to provide pedestrian safety. Inadequate sidewalk/crosswalk configurations will force pedestrians to walk in vehicular paths, which may result in increased pedestrian and vehicular conflicts.

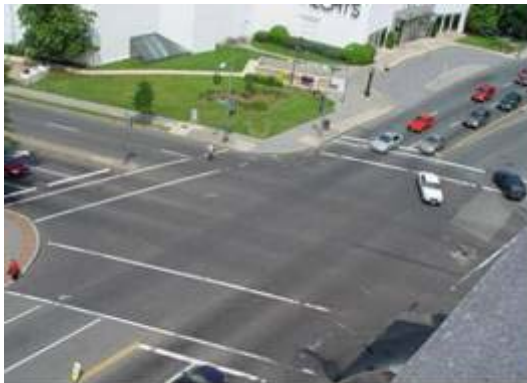
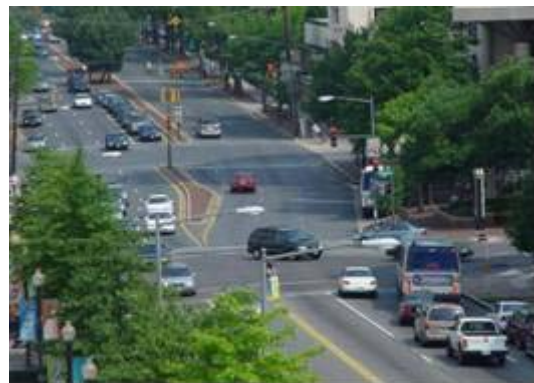
5.4.3 Wisconsin Avenue/Western Avenue Intersection

- Excessive queuing along Wisconsin southbound due to heavy volume of left turns heading eastbound onto Western Avenue. Although the left-most lane is not restricted to left turn only, the signal phasing prohibits the left turn during a portion of the through phase. This condition creates unsafe lane switching by through vehicles.

- High pedestrian movements and visitor confusion regarding location of entrances to Metro station.
- Poor roadway striping conditions.

- Re-stripe Wisconsin northbound, north of Western Avenue.
- Re-stripe pedestrian crossing as recommended in Section 5.8, Pedestrian Safety.
- Provide a detailed area map at the metro station to guide visitors and tourists.
- Install No Left Turn sign on the northwest corner for northbound vehicles.

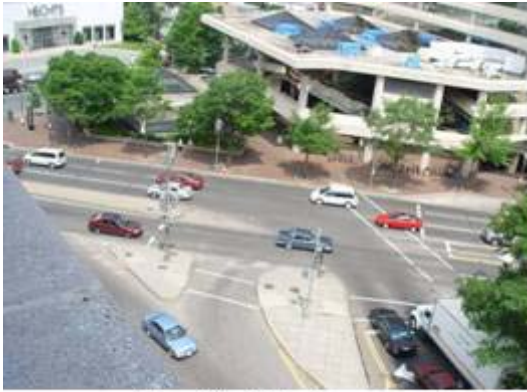
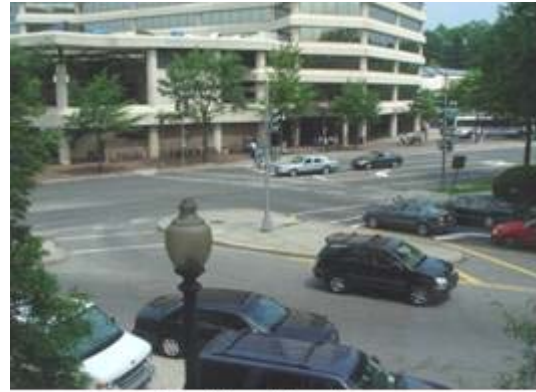
5.4.5 Western Avenue/Military Road Intersection

- Confusing intersection due to unconventional road alignment.
- Lack of queuing area along Western Avenue between Military Road and Wisconsin Avenue.
- Close proximity to Embassy Suites drop off area.
- Tight curb returns.
- Operation of intersection can be adversely affected by queuing of Military Road/41st Street/Reno Road intersection.
- Poor alignment and sidewalk condition for safe pedestrian and wheelchair crossings at the intersection.

- Improved alignment of crossing markings and island crossing will increase safety of pedestrians and handicapped traffic.

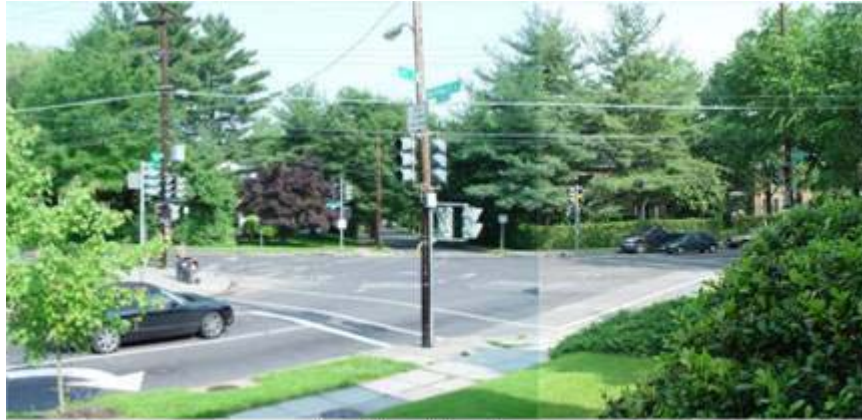
5.4.6 Western Avenue/41st Street/McKinley Street Intersection

- Signs prohibiting left-turns from Western Avenue westbound to 41st Street southbound are not being obeyed (no left turn between 7:00AM and 9:30AM). These left-turn violations cause significant back ups along Western Avenue westbound.
- Tight radii for large vehicle turning movements from all approaches.
- Poorly delineated pedestrian crossings.

- Increase enforcement of existing signage. Consider placement of traffic camera to record violations.
- Re-stripe pedestrian crossing as recommended in Section 5.8 Pedestrian Safety.
- Increase the radius in the southwest quadrant from Western Avenue eastbound onto 41st Street southbound.

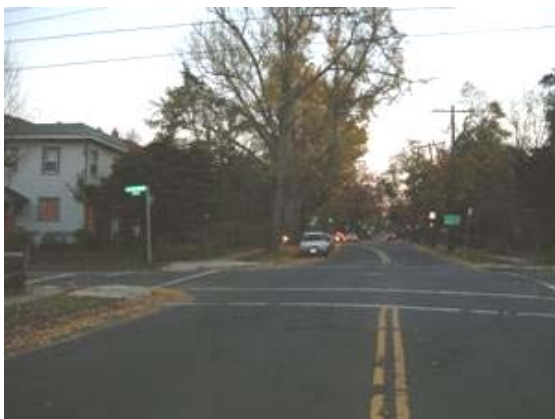
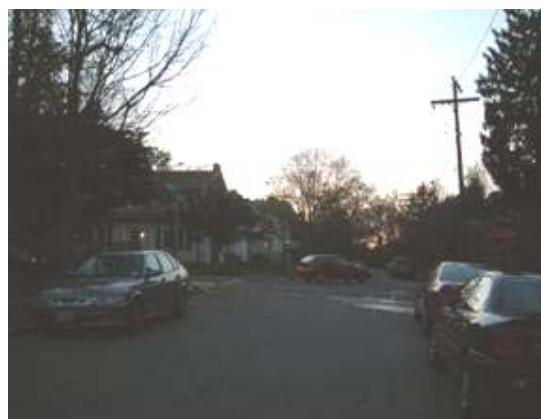
5.4.8 41st Street/Legation Intersection

- Faded crosswalks reduce driver visibility and decrease pedestrian safety.
- Vehicles parked too close to the intersection reduce driver visibility of on-coming vehicles.
- Pedestrian crossing signs will increase driver awareness of the potential pedestrian activity.

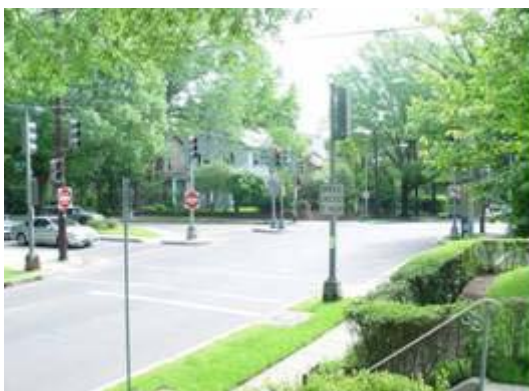
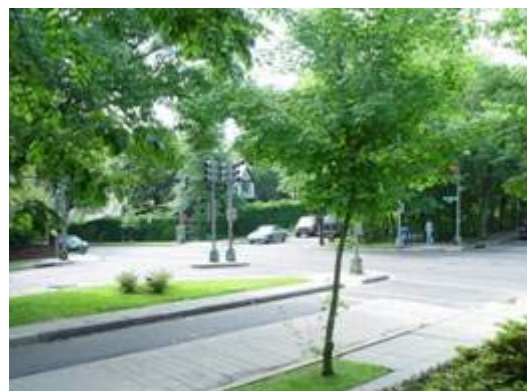
5.4.9 Military Road/41st Street/Reno Road Intersection

- Excessive queuing on Military Road heading eastbound, especially during the PM peak hour. The queuing has been observed to extend all the way back to Western Avenue.
- Confusing intersection for drivers due to proximity of the two signal systems.
- Poor signal timing. Currently, the existing signal system gives preference to the lower volume roads (41st Street and Reno Road vs. Military Road).
- Limited left-turn movements allowed.

- **ALTERNATIVE 1:** Close 41st Street south of the intersection by placing a temporary double-faced Jersey Barrier across the southern section of 41st Street. This will convert this complex, five-legged intersection into a simple four-legged intersection. Advance signage (eg. “No Outlet”) would be required at Jenifer Street and a small turn-around would need to be constructed. Remove the appropriate signal phase and retime remaining phases. This improvement should be tested for at least 90-days as recommended by DDOT before the permanent traffic movement change.
- If Alternative 1 is selected, replace the double-faced Jersey Barrier across southern section of 41st Street with a raised grassed panel or planter to make closure more permanent after the 90 day trial period.
- **ALTERNATIVE 2:** Make 41st Street one-way southbound from Military Road to Jenifer Street.

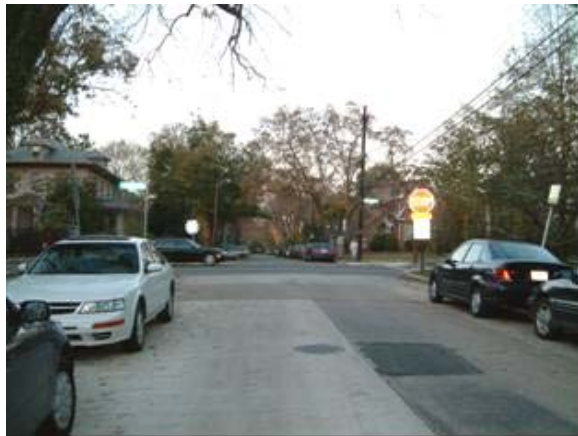
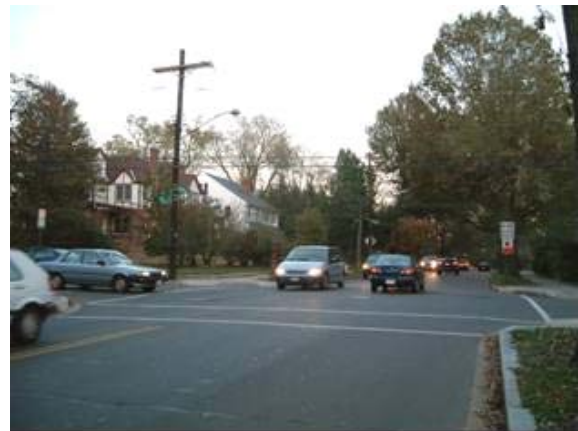
5.4.10 Military Road/42nd Street Intersection

- Although the 42nd Street northbound approach at Military Road is signed for “Right Turn Only”, drivers were observed making left turns and some through movement.
- Queuing on Military Road heading eastbound caused by the 41st Street intersection can extend beyond 42nd Street westward, blocking the intersection.
- Limited sight distance for vehicles entering onto Military Road from 42nd Street.
- Intersection is a high accident location.

- For the northbound approach, increase right turn radius and install a raised channelizing island to force drivers to make right turn only.
- Improvements recommended at 41st Street and at Western Avenue should significantly reduce the queuing problems.

- Installing “Do Not Block Intersection” signs will allow easier access to and from 42nd Street during period with length queues from other intersections.
- Improved signage will increase adherence to regulations
- Additional enforcement will increase adherence to regulations
- Installation of a positive barrier in the form of a raised island will make it difficult for drivers to complete the restricted movement.
- Removal of parking spaces will improve sight distance from 42nd Street.
- Having adequate sight distance will improve the safety for both vehicles and pedestrians.

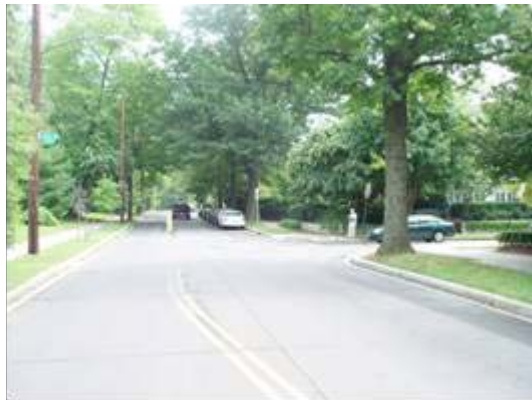
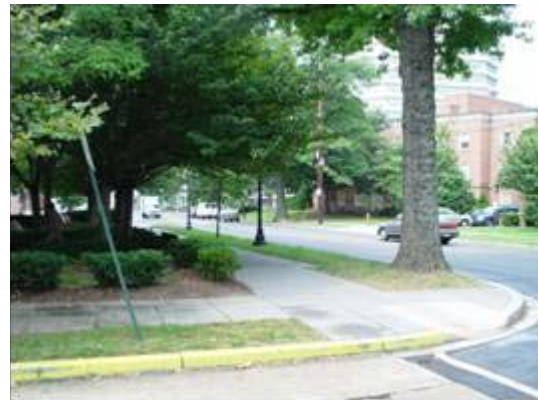
5.4.11 Military Road/43rd Street Intersection

- Faded pavement markings.
- Limited sight distance for vehicles entering onto Military Road from 43rd Street.
- Queuing on Military Road heading eastbound caused by the 41st Street intersection which can extend beyond 43rd Street westward, blocking the intersections along Military Road.
- Queuing on Military Road heading westbound caused by the Western Avenue intersection. Back-ups can extend beyond 43rd Street.
- High pedestrian volumes.
- Wheelchair ramps do not conform to ADA and DDOT standards.

- Improvements recommended at 41st Street and at Western Avenue should reduce the queuing problems.
- Reconstruct wheelchair ramps to current ADA and DDOT standards.

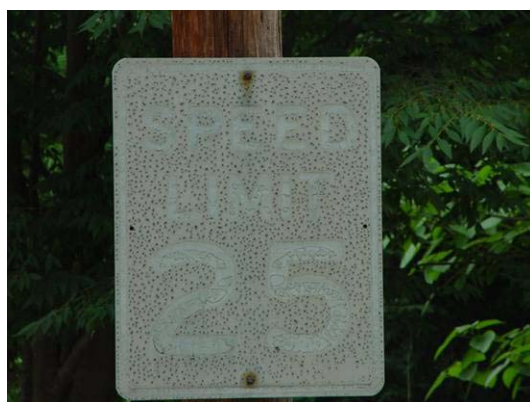
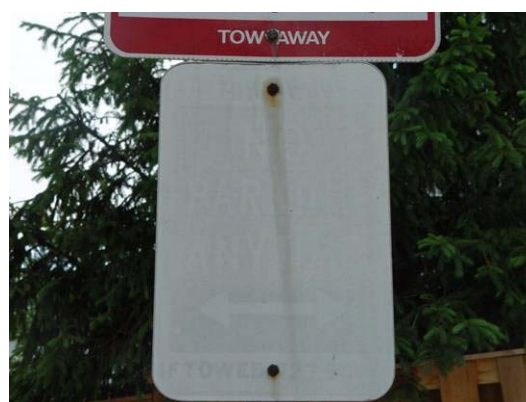
Faded / Worn Signs

- Some signs are faded beyond recognition.

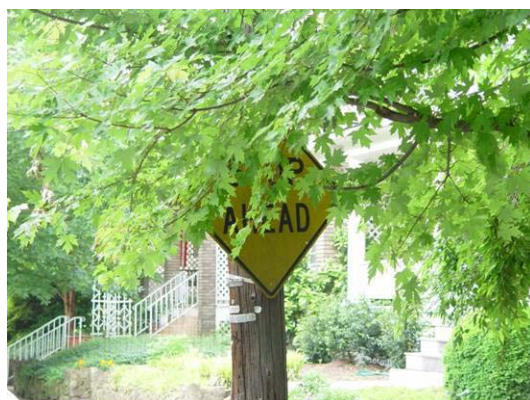
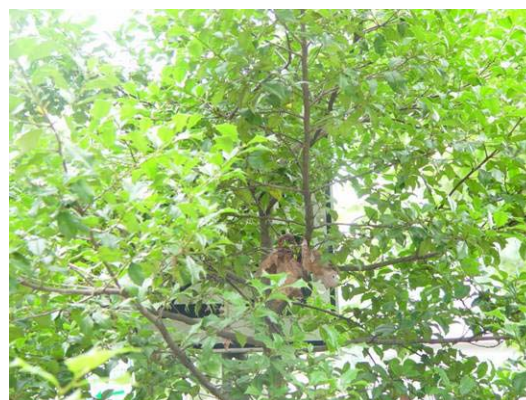
Obscured Signs

- Signs blocked by overgrown trees or shrubs.

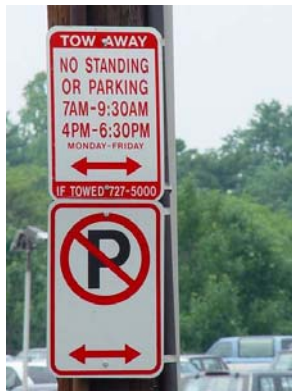
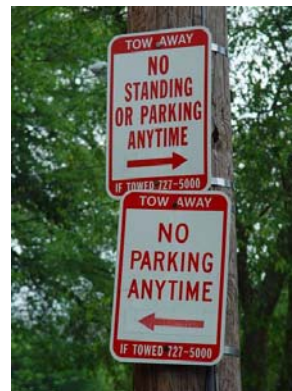
Conflicting / Extraneous Parking Signs

- Two separate signs in the same location giving different restrictions causing confusion.
- Multiple signs used in place of a single sign.

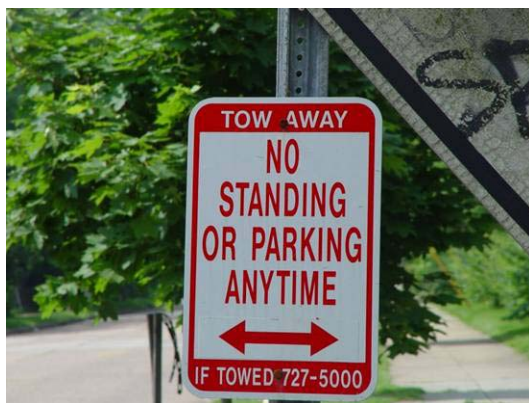
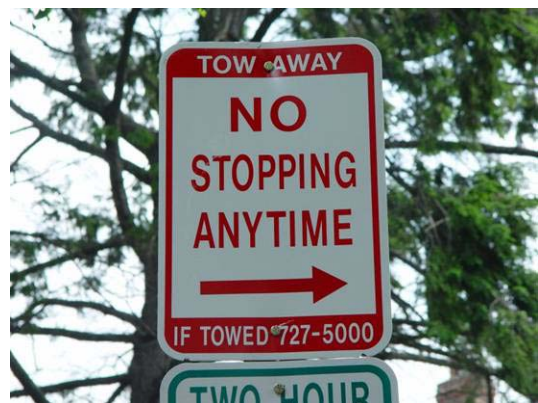
Inconsistent Wording on Signs

- Variable wording of restrictions throughout the study area can cause confusion.

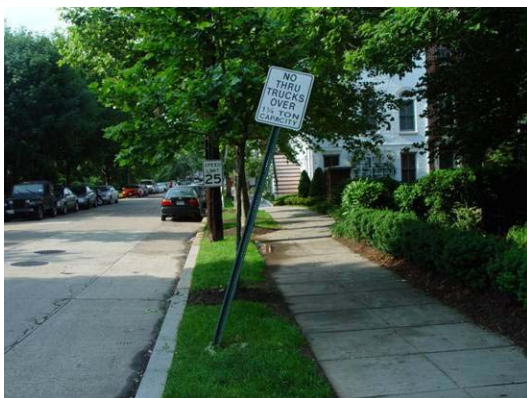
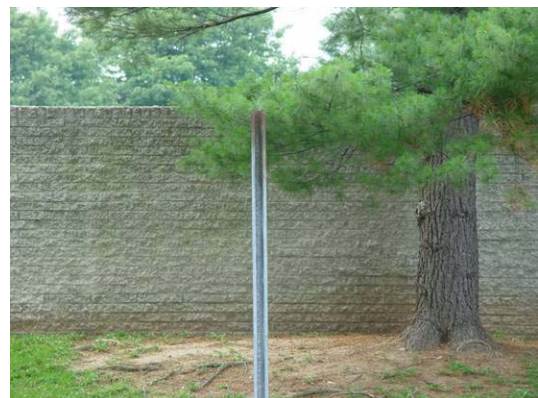
- General Maintenance
- Leaning signs are safety hazards.
- Bent, skewed, or misaligned makes it difficult to read or see.
- Completely out of the ground or panels removed from posts.

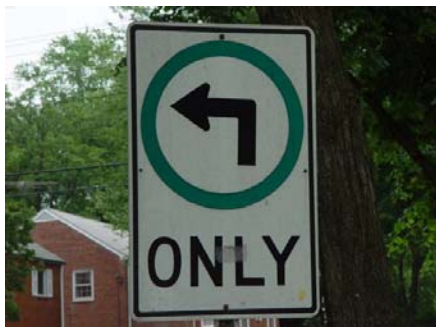
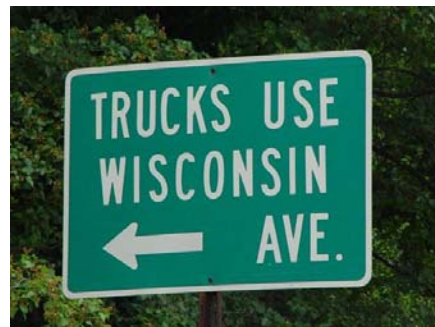
Non-Standard Signs

- Can cause confusion.
- Do not meet MUTCD standards.

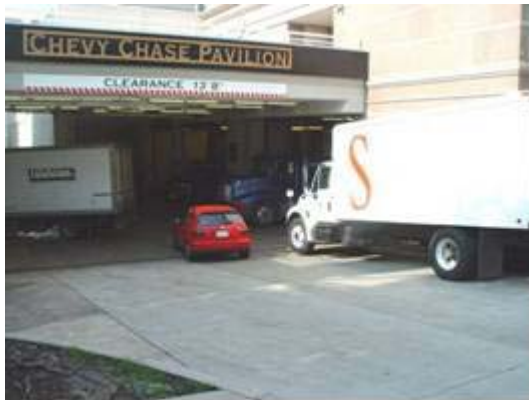
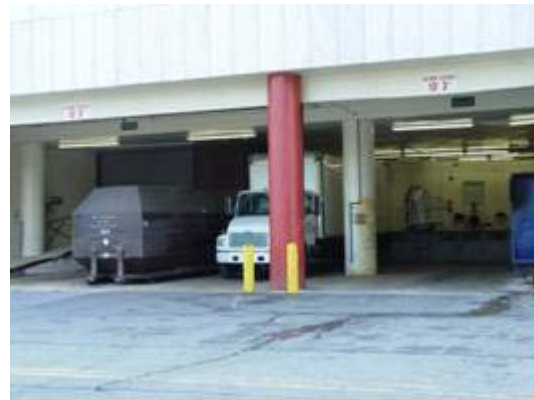
Chevy Chase Pavilion Loading Dock

Mazza Gallerie Loading Dock

- Northbound flow on Wisconsin Avenue during PM peak hour is restricted due to parking in the right lane.
- Limited access to Chevy Chase Pavilion parking garage and bellhop area of Embassy Suites due to road blockage caused by loading dock operations at Chevy Chase Pavilion.

- Improper use of the loading docks at area businesses.
- Some delivery trucks (for the building at 5225 Wisconsin Avenue) use the 5300 block of 43rd Street for loading, blocking the street.

- Extend peak parking restrictions for northbound Wisconsin Avenue to 7:00 PM.
- Remove trash dumpsters and improperly stored items from loading docks.
- Consider adding separate, marked parking areas for service vehicles.
- Loading dock manager should be more responsible for management of loading dock operations and their impact upon the public.
- Restrict illegal use of the valet parking in front of Maggiano's restaurant.
- Replace inconsistent parking restriction signs with one standard and consistent sign.
- Delineate limits of parking between intersections within the study area with a "L" shaped pavement marking placed approximately 25' from curb return.
- DDOT will work with the building manager at 5225 Wisconsin Avenue to see if they can/will allow other deliveries in their block.
